## CLARITY CAM COVER

### PRODUCT DESCRIPTION

2001-2012 Twin Cam Models except 2001-2012 FL Touring models.

0177-2003

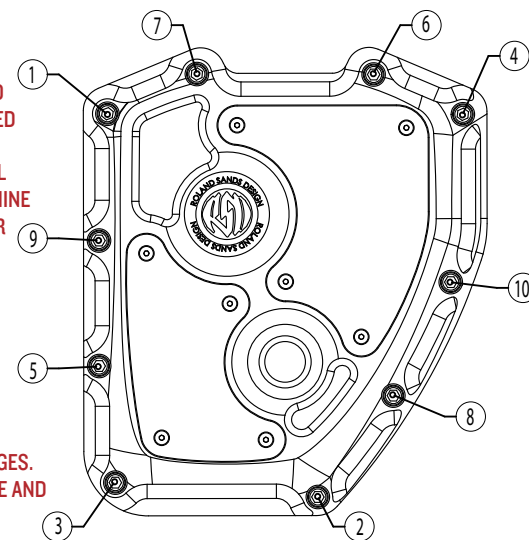
**NOTE: Make sure the inside of the Lexan window is clean prior to installation. Clean with Plexus if necessary.**
5. Torque the 1/4-20 x 1" bolts to 105 in-lbs using the torque sequence shown in Fig A below.

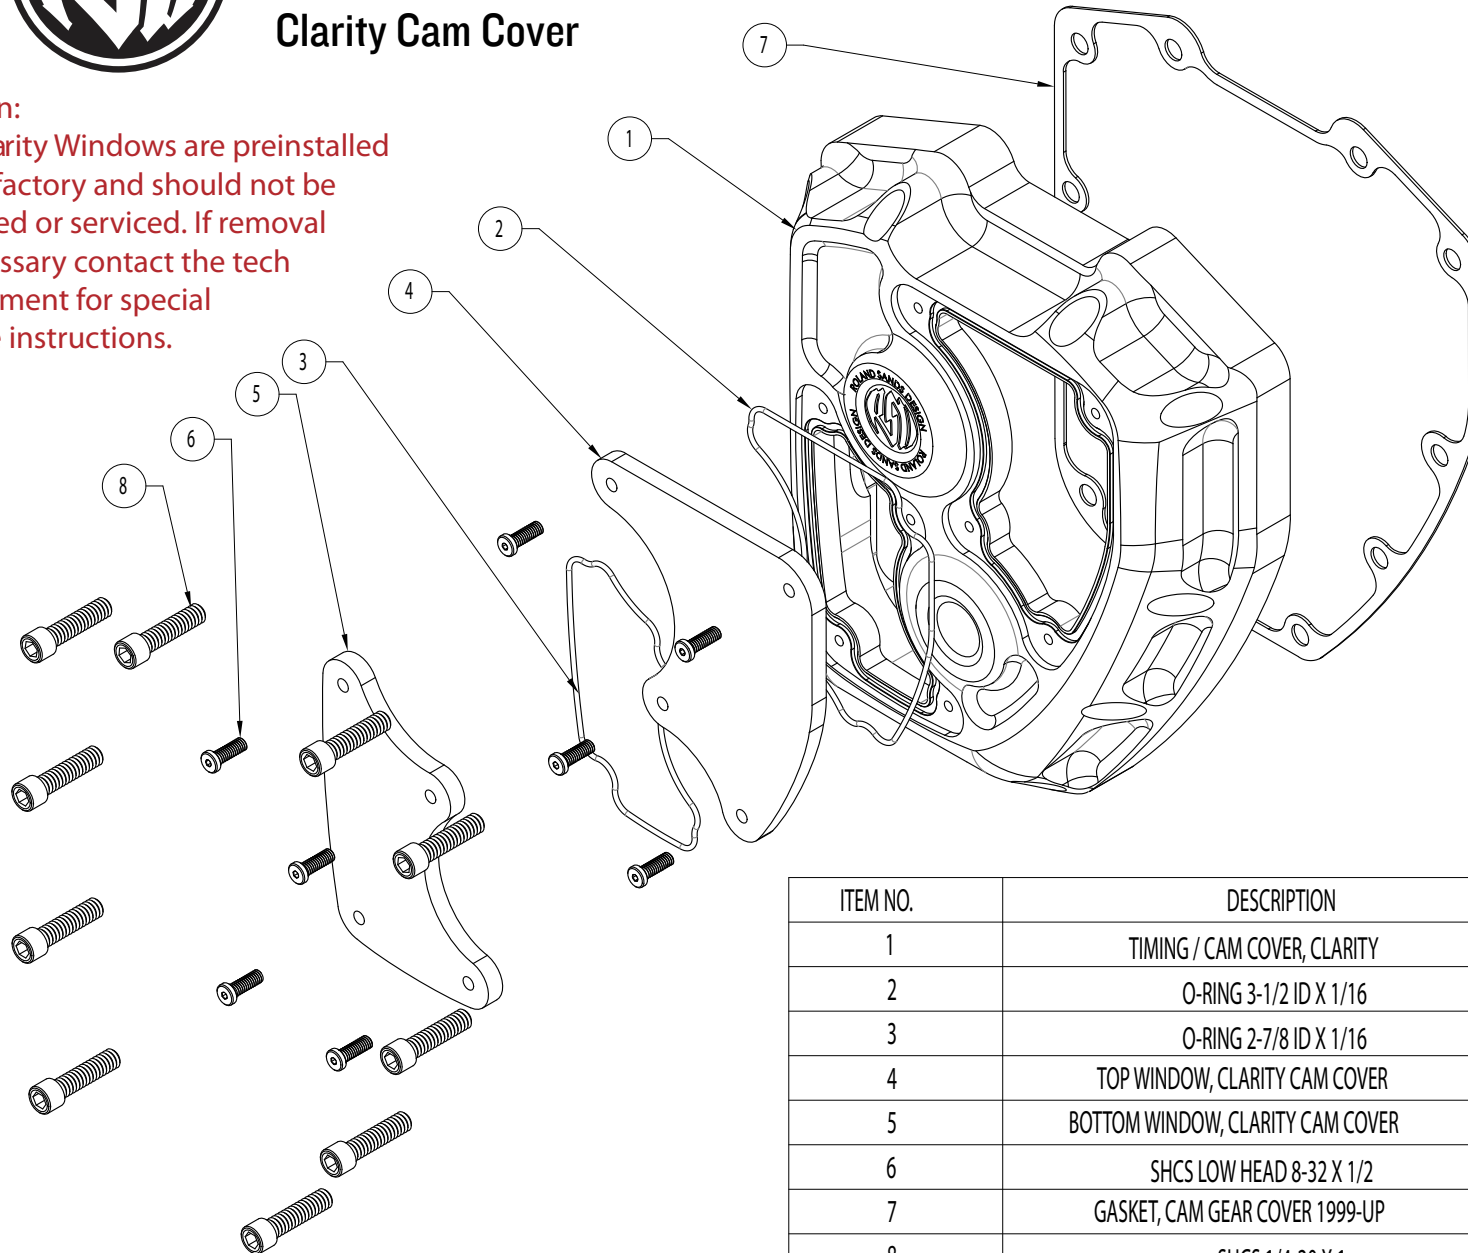
**Caution:**  
The Clarity Windows are preinstalled at the factory and should not be removed or serviced. If removal is necessary contact the tech department for special service instructions.

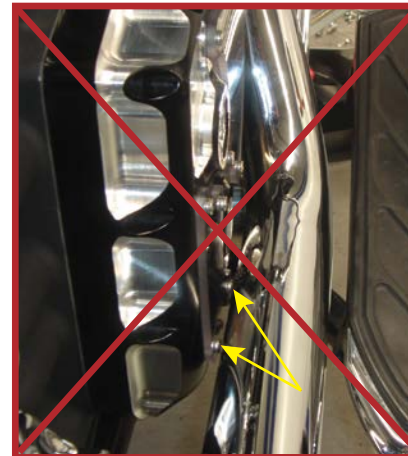
### 2000-08 FL MODELS: INADEQUATE CLEARANCE

-CONTACT WITH BOLT HEADS WILL CAUSE SEVERE LEXAN FAILURE!

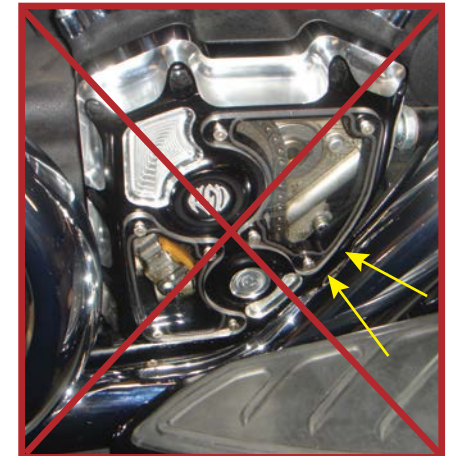
### 2009-12 FL MODELS: INADEQUATE CLEARANCE

-CONTACT WITH ALUMINUM HOUSING WILL CAUSE SEVERE LEXAN FAILURE!

Warning: Contact may occur on Softail & Dyna models. Always check exhaust clearances during installation.
